Manhole Inspection Summary

Manhole # S31II1006MH

Insp Date: **3/20/07 8:08 AM**

Location Address: **TUSCANY RD**

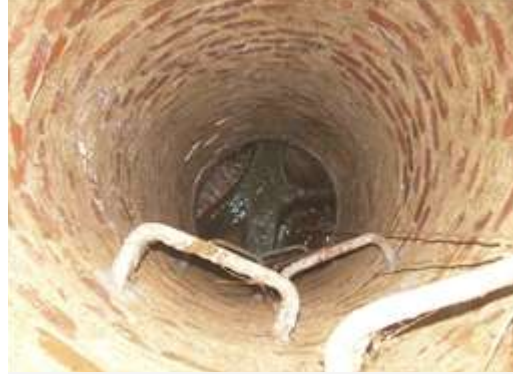
Top View

Bench debris.

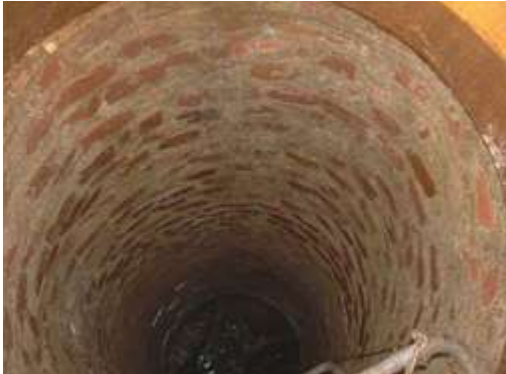
Defect

Frame leaks. Frame offset. Adjustment, Corbel and Barrel infiltration.

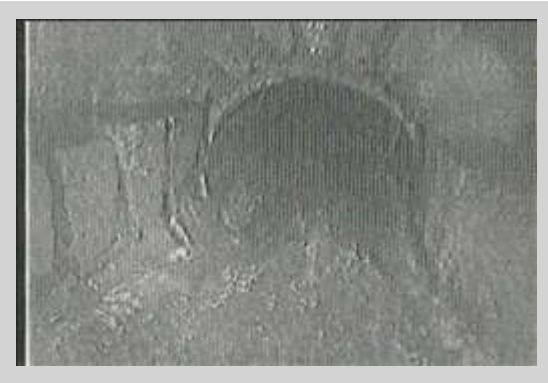
12 in. Circular Gravity Sewer Pipe Out @ 12 O'Clock

Infiltration: **None** Pipe Seal Cond: **Roots**

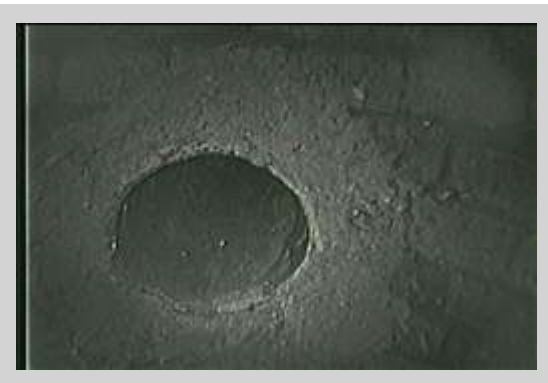
8 in. Circular Gravity Sewer Pipe In @ 3 O'Clock

Infiltration: **Evidence** Pipe Seal Cond: **Broken**

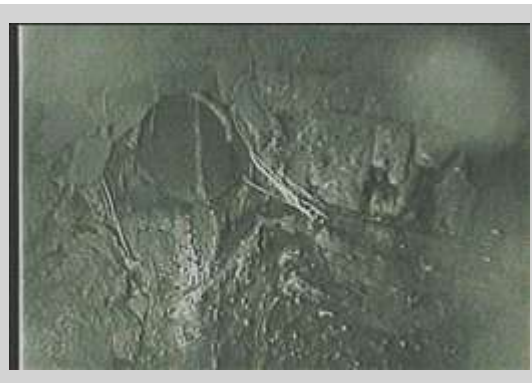
Drop In @ 3 O'Clock

Barrel root intrusion and infiltration. Channel deterioration and cracks.

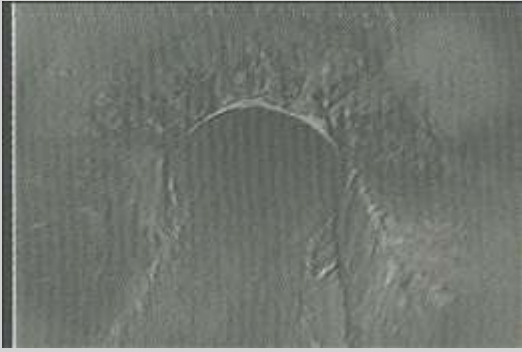
Pipe In @ 6 O'Clock

Infiltration: **None** Pipe Seal Cond: **Cracked**

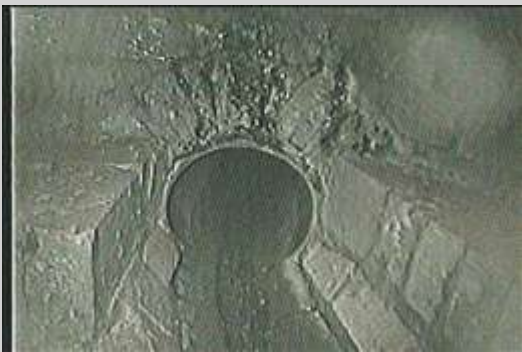
Pipe In @ 8 O'Clock

Deposits: ☐ None ☒ **Mud** ☐ Sludge ☒ **Debris** ☐ Grease

Silt Depth: **0.5** (in.) Deposits Extent: **Light**
